# United States Coast Guard

## Marine Safety Alert

Alert 1-05

#### **GPS Receiver Manually-Entered Position Offsets May Cause Safety Hazard when Interconnected to Navigation Devices**

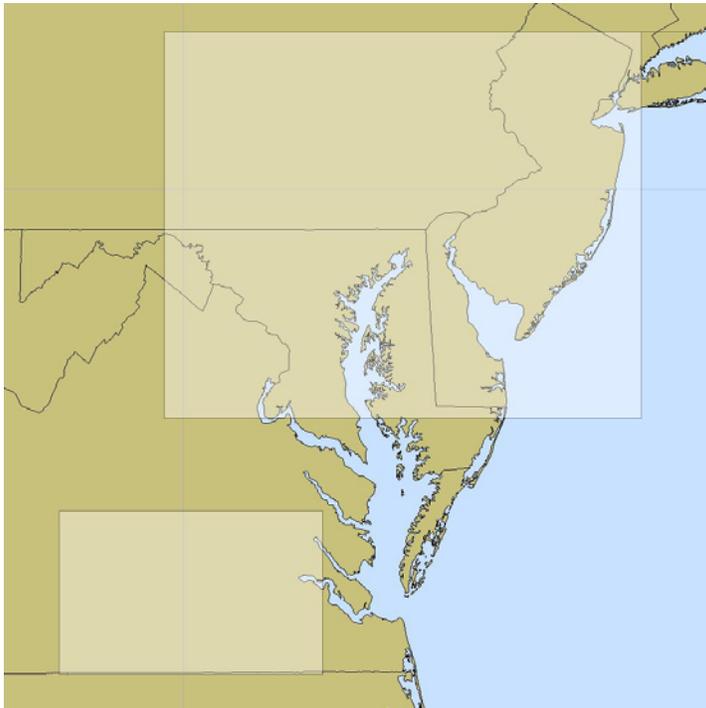
Between July 27<sup>th</sup> and August 19<sup>th</sup>, 2010, while conducting development testing of its Nationwide Automatic Identification System (NAIS), the Coast Guard inadvertently tele-commanded most AIS users transiting the Eastern United States between lower Connecticut and North Carolina to switch to AIS frequencies other than the AIS default frequencies (161.975 MHz - Channel 87B - 2087 and 162.025 MHz - Channel 88B - 2088). As a result, those users within uniquely defined channel management regions (as shown in the picture) will neither see nor

be seen by vessels operating on the default AIS channels when within these regions. Similarly, vessels operating on default frequencies will not see or be seen by those vessels that were inadvertently switched to other frequencies. No other AIS users or areas are impacted.

Commencing September 1<sup>st</sup> and continuing for the subsequent 5 weeks, the Coast Guard will broadcast new channel management messages that will telecommand all AIS users back to default channels. This broadcast will occur each hour between hh.05:30 and hh.05:59, but may change as needed. To ensure that these messages are received, they will be broadcast on Channel 70--Digital Selective Calling (DSC), which is also monitored by all type-certified shipboard AIS. While this will ensure all AIS users will get the message regardless of what AIS channel the unit is operating on, it could however cause a minor inconvenience to owners of older DSC radios who may receive an alert (tone) upon receipt of this message. It will have no other effect on DSC radios.
