United States Coast Guard

Marine Safety Alert

Alert 1-05

GPS Receiver Manually-Entered Position Offsets May Cause Safety Hazard when Interconnected to Navigation Devices

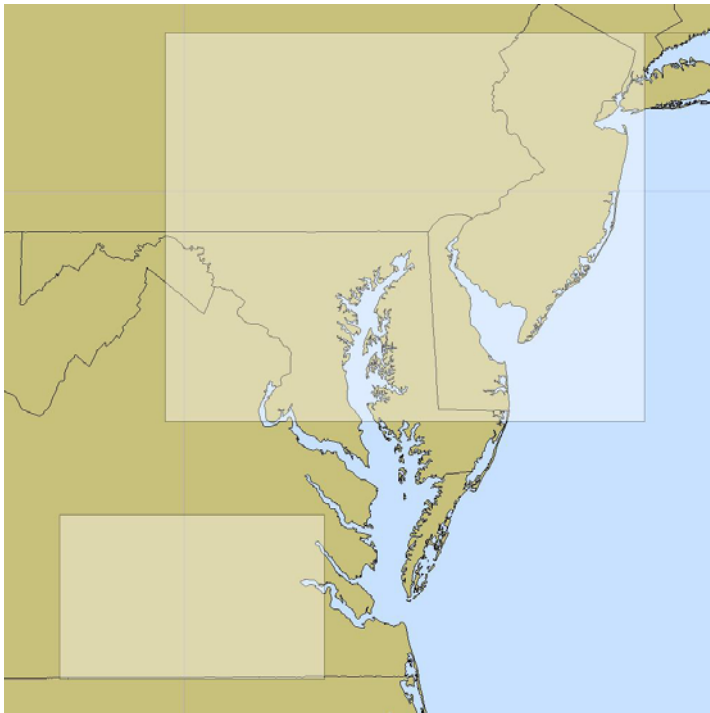
Between July 27th and August 19th, 2010, while conducting development testing of its Nationwide Automatic Identification System (NAIS), the Coast Guard inadvertently tele-commanded most AIS users transiting the Eastern United States between lower Connecticut and North Carolina to switch to AIS frequencies other than the AIS default frequencies (161.975 MHz - Channel 87B - 2087 and 162.025 MHz - Channel 88B - 2088). As a result, those users within uniquely defined channel management regions (as shown in the picture) will neither see nor

be seen by vessels operating on the default AIS channels when within these regions. Similarly, vessels operating on default frequencies will not see or be seen by those vessels that were inadvertently switched to other frequencies. No other AIS users or areas are impacted.

Commencing September 1st and continuing for the subsequent 5 weeks, the Coast Guard will broadcast new channel management messages that will telecommand all AIS users back to default channels. This broadcast will occur each hour between hh.05:30 and hh.05:59, but may change as needed. To ensure that these messages are received, they will be broadcast on Channel 70--Digital Selective Calling (DSC), which is also monitored by all type-certified shipboard AIS. While this will ensure all AIS users will get the message regardless of what AIS channel the unit is operating on, it could however cause a minor inconvenience to owners of older DSC radios who may receive an alert (tone) upon receipt of this message. It will have no other effect on DSC radios.
